Low temperature crack propagation in nuclear shut-down water chemistry of Alloy 52 with potential effects of hydrogen

Low temperature crack propagation in nuclear shutdown water chemistry of Alloy 52 with potential effects of hydrogen

**Final Report from the NKS-R FEMMA activity
(Contract: AFT/NKS-R(25)134/1)**

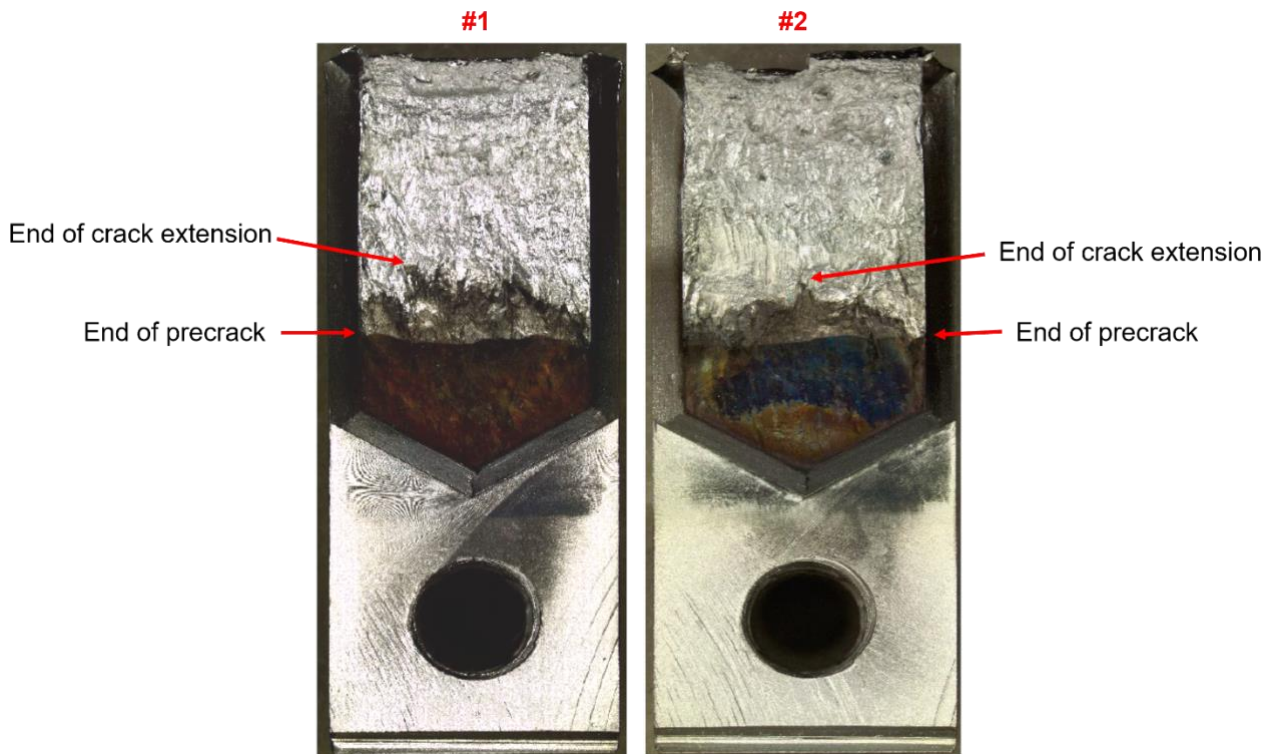
The specimens precracked and bolt loaded to $20 \text{ MPa} \sqrt{\text{m}}$ were exposed in vessels, where the reactor water flows through the loop at a rate of 0.2 kg/s . The electrochemical potential (ECP) of the plant hydrogenated water chemistry (HWC) is around -300 mV/SHE . The hydrogen charging of the feedwater can be up to $0.5\text{--}1.5 \text{ ppm}$ to keep the ECP measurements that are taken in recirculation loop and main circulation loop below -230 mV/SHE . The temperature and pressure in the test loop were the same as in the reactor pressure vessel, i.e. $275 \text{ }^\circ\text{C}$ and 7 MPa . The specimens were exposed to hot hydrogenated water during 2001 to 2013 with a total of 81702 h . The reactor was completely shut down in 2013. The test loop and water circulation system were exposed to shutdown water chemistry during 2013–2016. After the shutdown, the hydrogen addition was stopped. There is no circulation during the cold period since the valves were closed. The temperature at the autoclave is suspected to be around $30\text{--}40 \text{ }^\circ\text{C}$ in the post-shutdown periods. The specimens were opened after the exposure first by fatigue and then overloading. The optical microscopy images in Figure 1 reveals a black-color pre-fatigue area and a brown-color crack extension area. With a faster oxide film growth rate at high temperatures due to faster kinetics, the pre-fatigue region exhibits a thicker and thus darker oxide under optical microscopy. The darker pre-fatigue region was supposed to go through the reactor operation periods and also the cold shutdown period while the lighter crack extension region merely occurred during the final cold period.

Figure 1: The optical microscopy images of specimens.

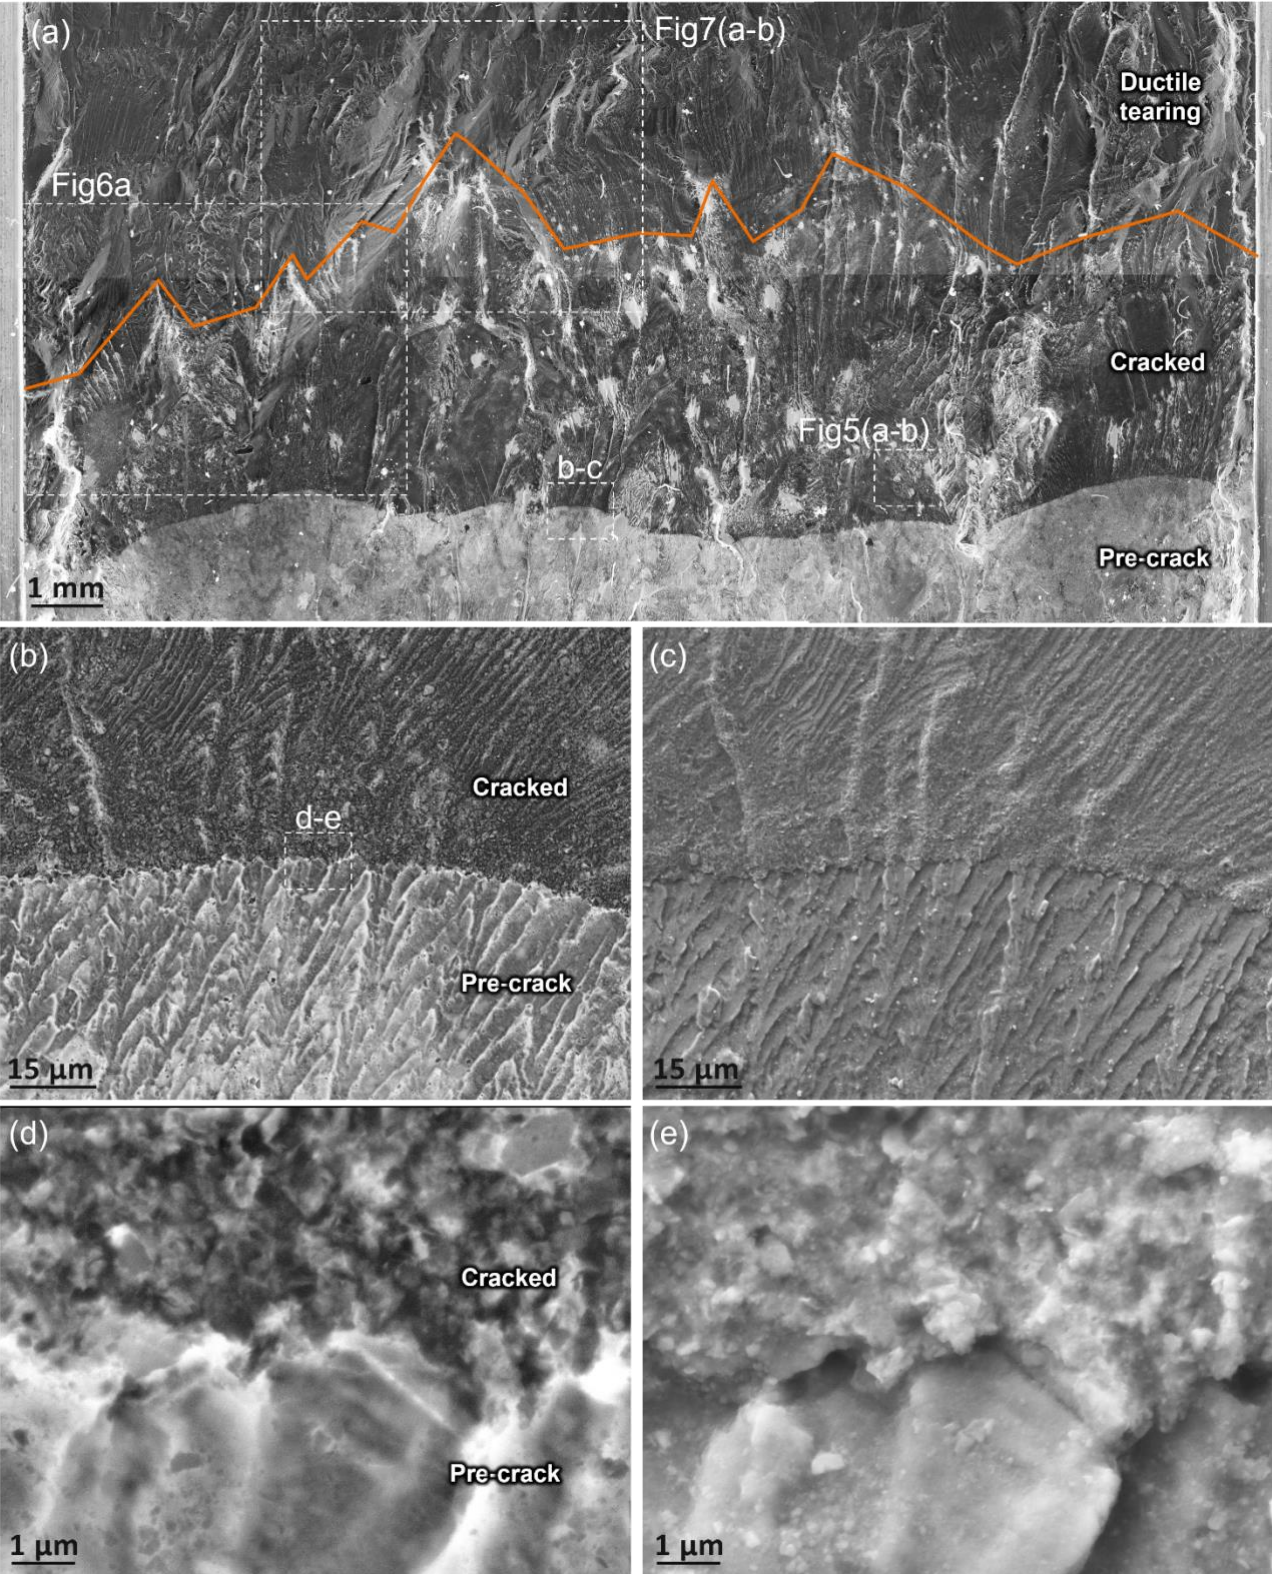
The SEM images of fractography are shown in Figure 2. The pre-fatigue region reveals a much whiter contrast under the backscattered electron detector, which is due to the thicker oxide layers formed on pre-fatigue region during the high-temperature reactor operation periods. It reveals that the cracked region exhibits a similar contrast in brightness as the post-

exposure region with ductile tearing under the backscattered electron detector, which demonstrated that the crack extension region merely occurred during the cold shutdown period. SEM observations of the fracture surfaces of cracked region showed a transgranular fracture mode.

Figure 2: The SEM images of fractography on specimen #1 and the transition line between fatigue pre-crack to cracked region. (a, b and d) images by backscattered electron detector; (c, e) images by secondary electron detector.

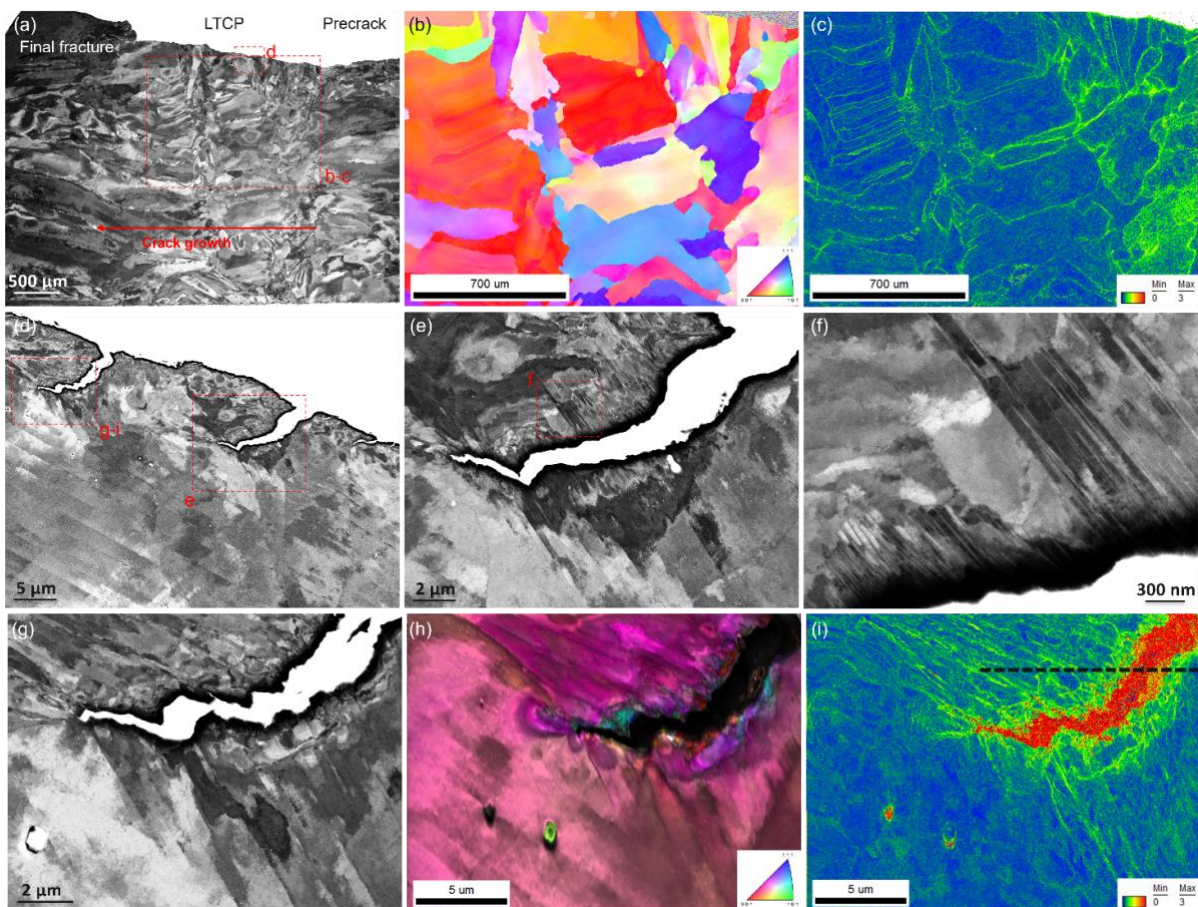
The cross-sectional SEM and EBSD images are shown in Figure 3. As shown in Figure 3(d), extensive secondary cracks were formed in crack-extended region. A very thin oxide layer was observed (the thin-region adjacent to the crack with black contrast in Figure 3(e-g)), particularly in the crack-extended regions, which confirms the decreasing ECP during the cold period. Localized deformation with extensive formation of shear bands in cracked extended region were observed, particularly ahead of the crack tips (Figure 3(h-i)).

In general, the plastic deformation is not localized beneath the main cracked surface, as shown by the cross sectional EBSD aligned with (in Figure 3(b-c)) the crack growth direction. It demonstrates that plasticity is only localized ahead of the crack tips, where extensive shear bands and nano-twins were formed.

Figure 3: The cross-sectional SEM and EBSD images of specimen #2. The cross section was prepared aligned with the crack growth direction. (a, d-g) images by backscattered electron detector; (b, h) IPF figures; (c, i) KAM figures.

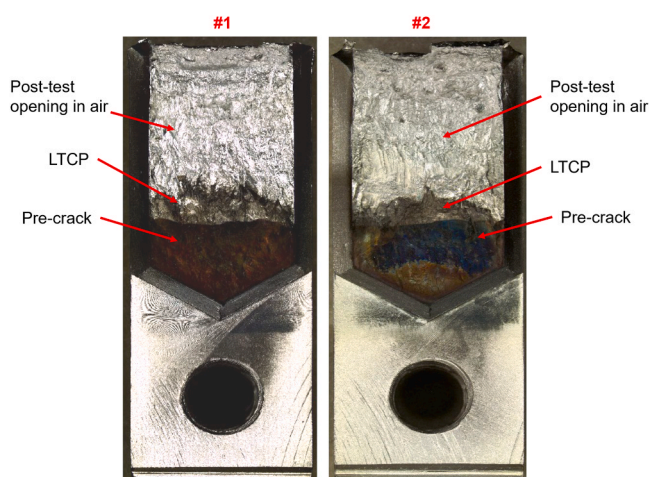
The optical microscopy images in Fig. 3 reveal a black-color pre-fatigue area and a brown-color crack extension area. The metallic, shiny region observed under optical microscopy indicates areas that experienced post-test opening in air. With a faster oxide film growth rate at high temperatures due to faster kinetics, the pre-fatigue region exhibits a thicker and thus darker oxide under optical microscopy. The darker pre-fatigue region was supposed to go through the reactor operation periods and the post-shutdown cold period while the lighter crack extension region is assumed to primarily occur during the post-shutdown cold period. Table 3 lists the reactor operation periods and the total exposure time of the specimens. Crack growth rates (CGRs) were calculated under two assumptions: that all crack advance occurred during the high-temperature exposure, or that all of it occurred during the post-shutdown exposure.

Fig. 3. Optical microscopy images of specimens.

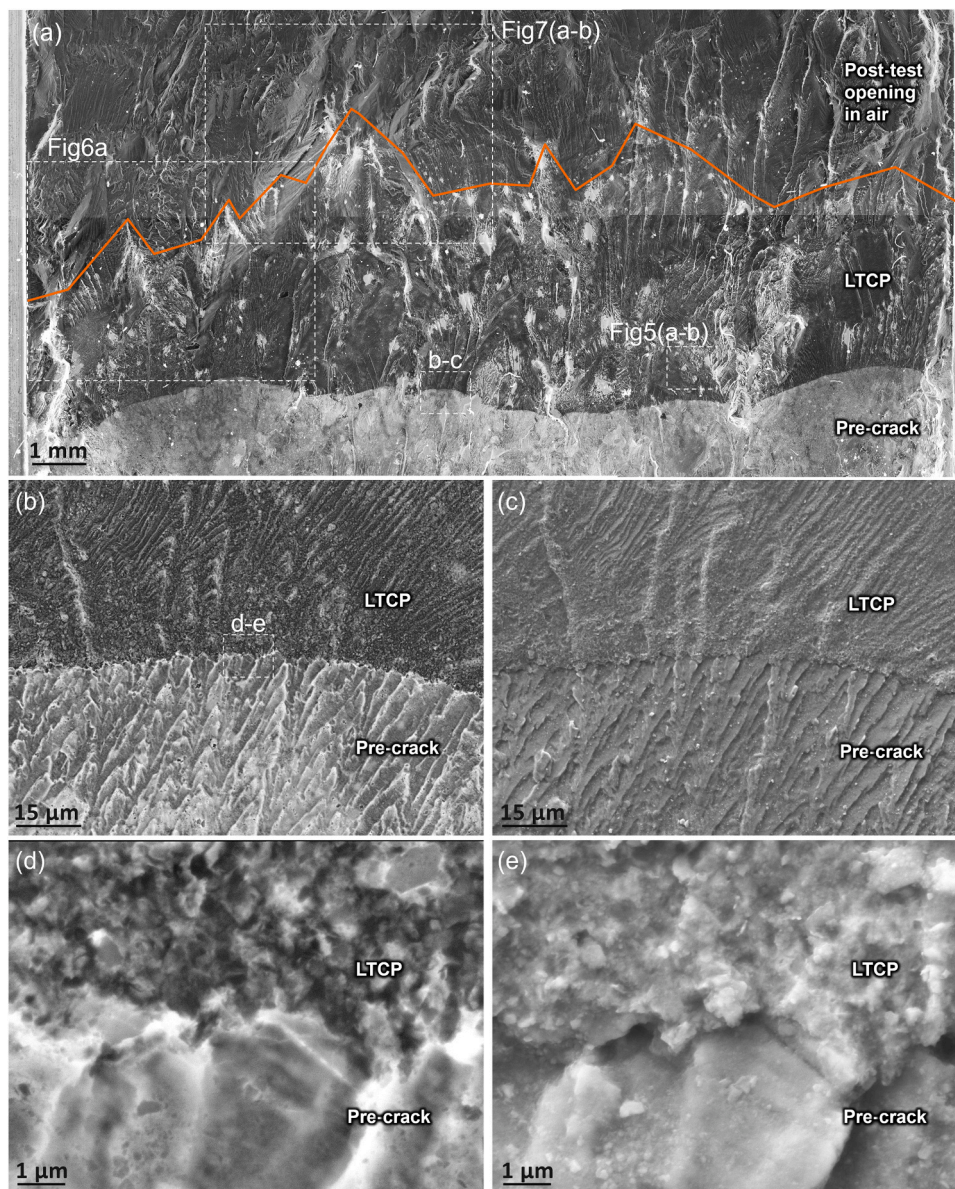
SEM images of the fracture surfaces of specimen #1 are shown in Fig. 4 to Fig. 7. In Fig. 4(b,d), the pre-fatigue region displays a noticeably brighter contrast under the backscattered electron detector, consistent with the formation of thicker oxide layers during high-temperature reactor operation. Fig. 4(a) reveals that the crack extended region exhibits a contrast similar to the post-test opening region in air, implying that crack extension occurred primarily during the post-shutdown cold period. The appearance of the fracture surface suggests that crack extension occurred in a single event, with no signs of stepwise macroscopic propagation.

Detailed SEM observations of the crack extended region reveal a predominantly transgranular fracture mode. The fracture surface is characterized by parallel lines typical of intermittent crack growth, extending over large areas across multiple grains. These features are uniform across grains of different orientations and are not consistent with fatigue (e.g., beach marks or fatigue striations) nor with classical transgranular stress corrosion cracking (e.g., cleavage-like facets or river patterns). These observations indicate that the fracture behavior in the crack extended region reflects a distinct deformation and crack propagation mechanism, associated with post-shutdown cold conditions rather than fatigue or conventional SCC.

Fig. 4. SEM images of fractography on specimen #1 and the transition line between fatigue pre-crack to cracked region. (a, b and d) images by backscattered electron detector; (c, e) images by secondary electron detector. "Pre-crack", "LTCP" and "Post-test opening in air" indicate regions of pre-cracking, crack extension in post-shutdown cold water, and post-test fatigue and tearing in air, respectively.

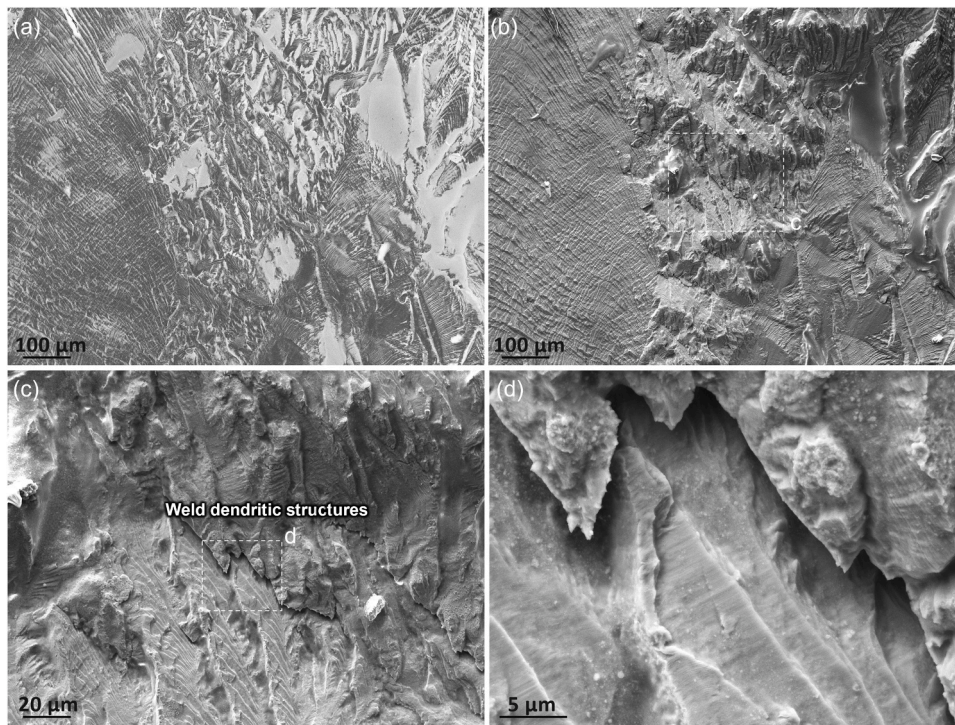
Fig. 5 shows the detailed fractography on the crack extended region with a 1 mm crack extension. Weld dendritic features can be seen in some local areas but no interdendritic fracture was revealed (Fig. 5(b)).

Fig. 5. SEM images of fractography on specimen #1 and the detailed feature on cracked region with a 1 mm crack extension. (a) image by backscattered electron detector; (b-d) images by secondary electron detector.

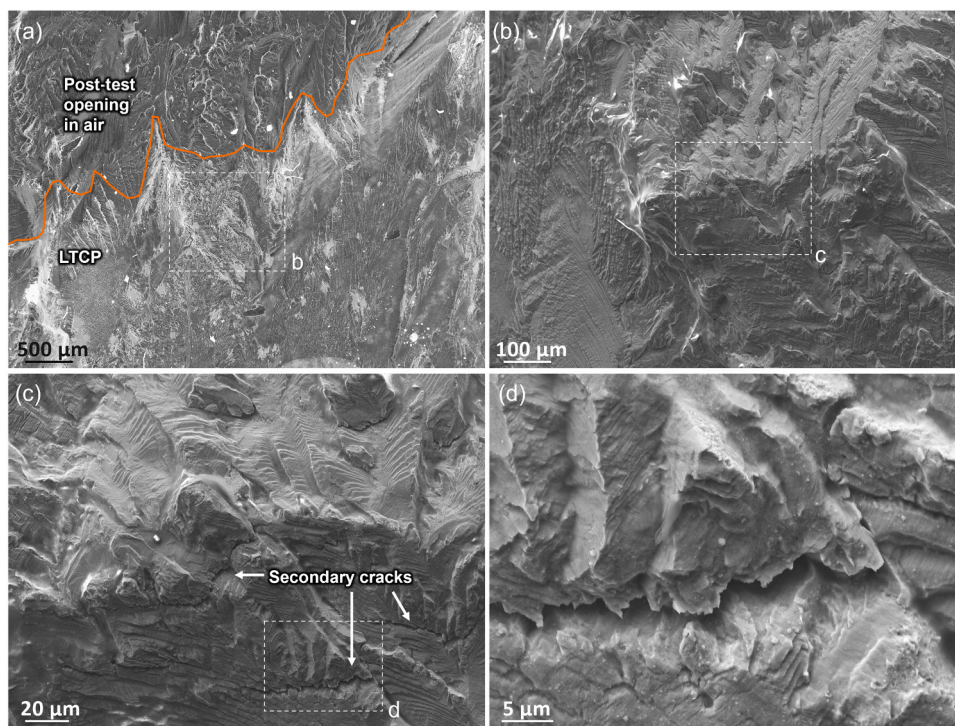
Fig. 6 presents detailed fractography of the crack extended region with a 3 mm crack extension. Most areas of the crack are very clean, without continuous oxide layers (Fig. 6(a)). SEM observations confirm a transgranular fracture mode, without intergranular or interdendritic features. Some secondary cracks are locally observed (Fig. 6(c-d)).

Fig. 6. SEM images of fractography on specimen #1 and the detailed feature on crack extended region with a 3 mm crack extension. (a) image by backscattered electron detector; (b-c) images by secondary electron detector.

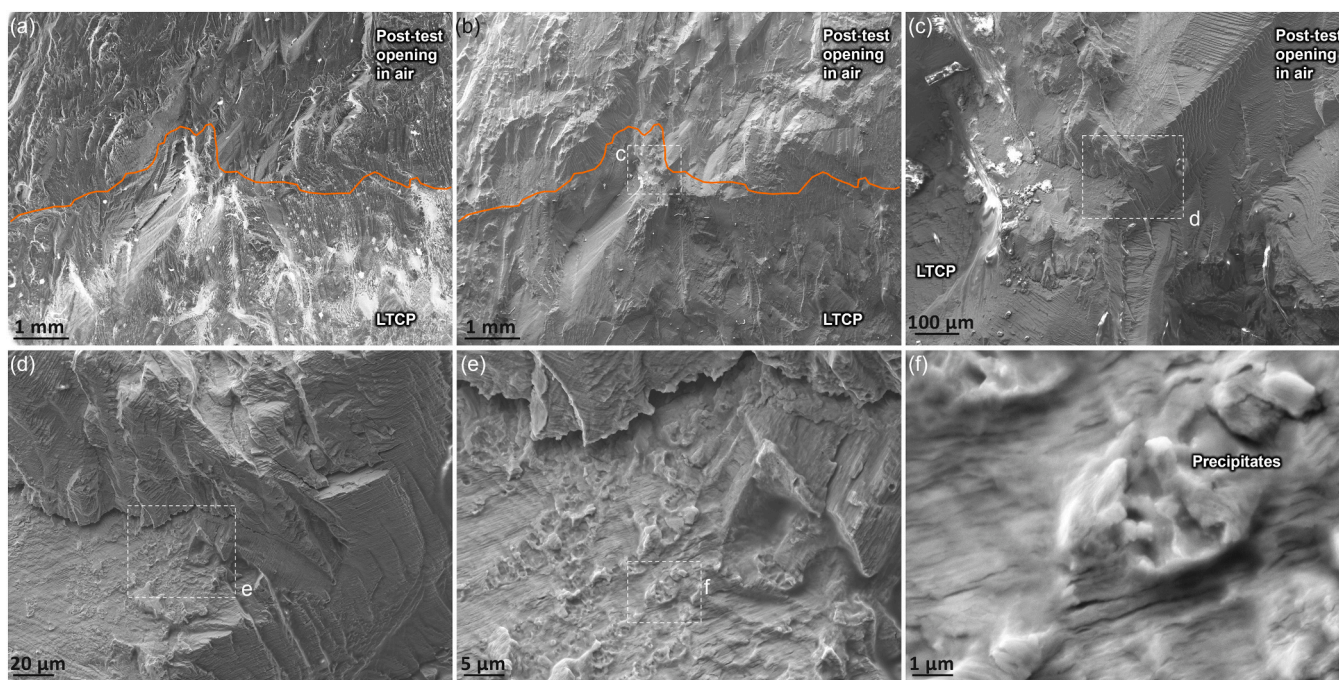
Fig. 7 depicts the fractography of crack extended regions that are close to the end of the post-shutdown cold exposure period. The

precipitates can be observed locally. Fig. 7 reveals that the crack extended region exhibits a similar fracture mode as the post-test opening region in air. In Fig. 7(e-f), precipitate-rich fracture surface was observed locally.

Fig. 7. SEM images of fractography on specimen #1 and the detailed feature on cracked region with a 4 mm crack extension and close to the end of the exposure period. (a) image by backscattered electron detector; (b-f) images by secondary electron detector.

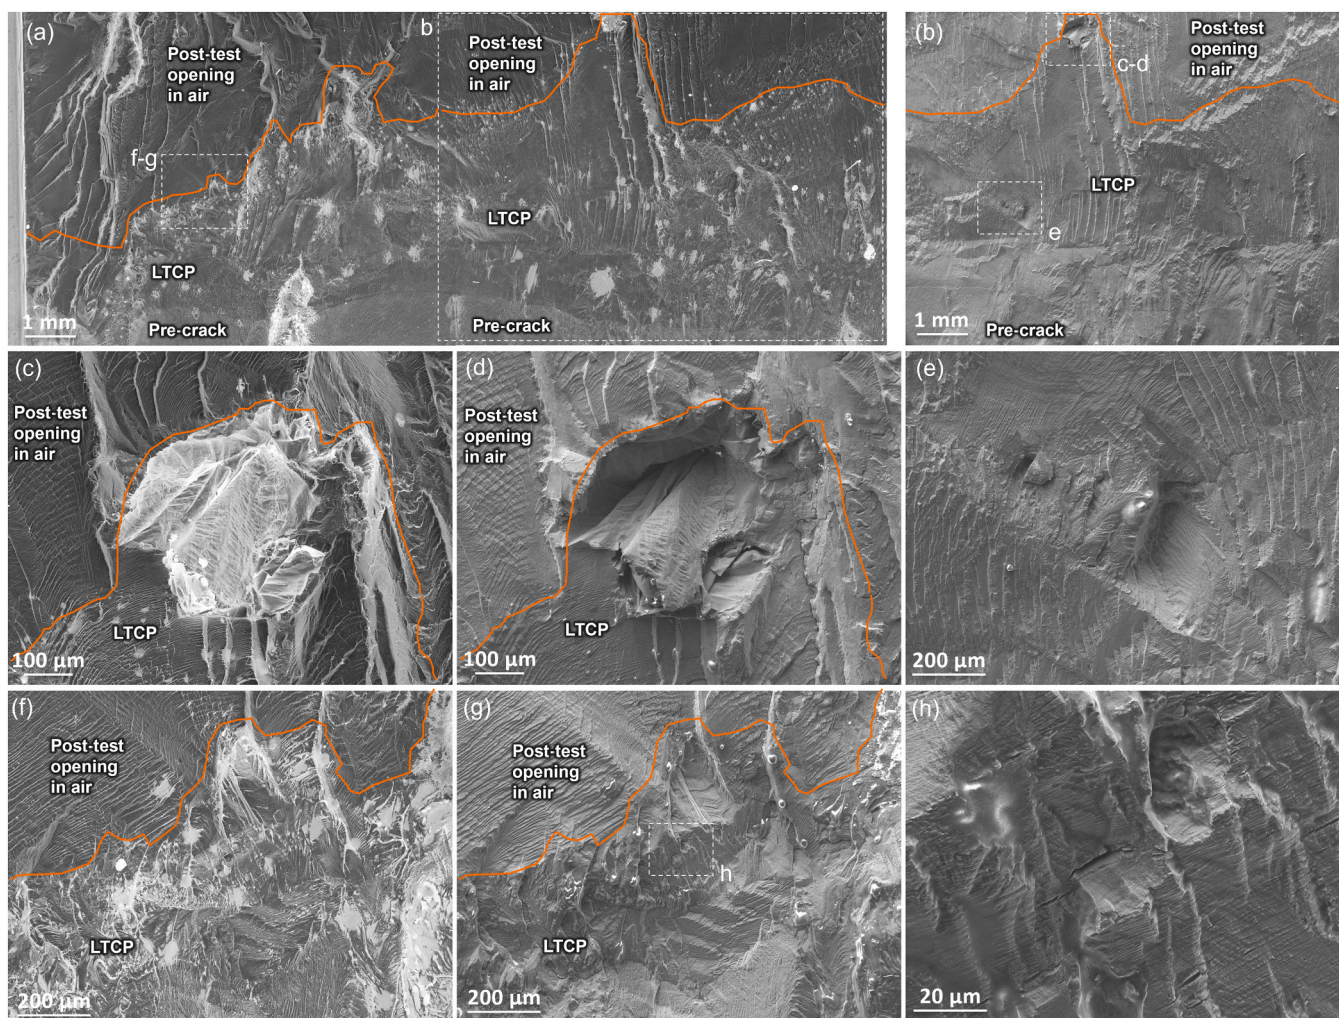
The SEM images of fractography on specimen #2 are shown in Fig. 8. The fracture surface of specimen #2 is generally similar to that of specimen #1. The dominant fracture mode throughout the cracked region is transgranular without ductile dimples. There is no obvious intergranular nor interdendritic fracture. Locally some weld bead

structure (Fig. 8(d,g)) or secondary cracks (Fig. 8(h)) are visible. In summary, the fractographic analysis of specimens #1 and #2 indicates a predominantly transgranular fracture mode, with small localized intergranular or interdendritic features accounting for only approximately 1–2 % of the total fracture surface. Additionally, secondary cracking is

Fig. 8. SEM images of fractography on specimen #2. (a, c and f) images by backscattered electron detector; (b, d-e and g-h) images by secondary electron detector. "Pre-crack", "LTCP" and "Post-test opening in air" indicate regions of pre-cracking, crack extension in post-shutdown cold water, and post-test fatigue and tearing in air, respectively.

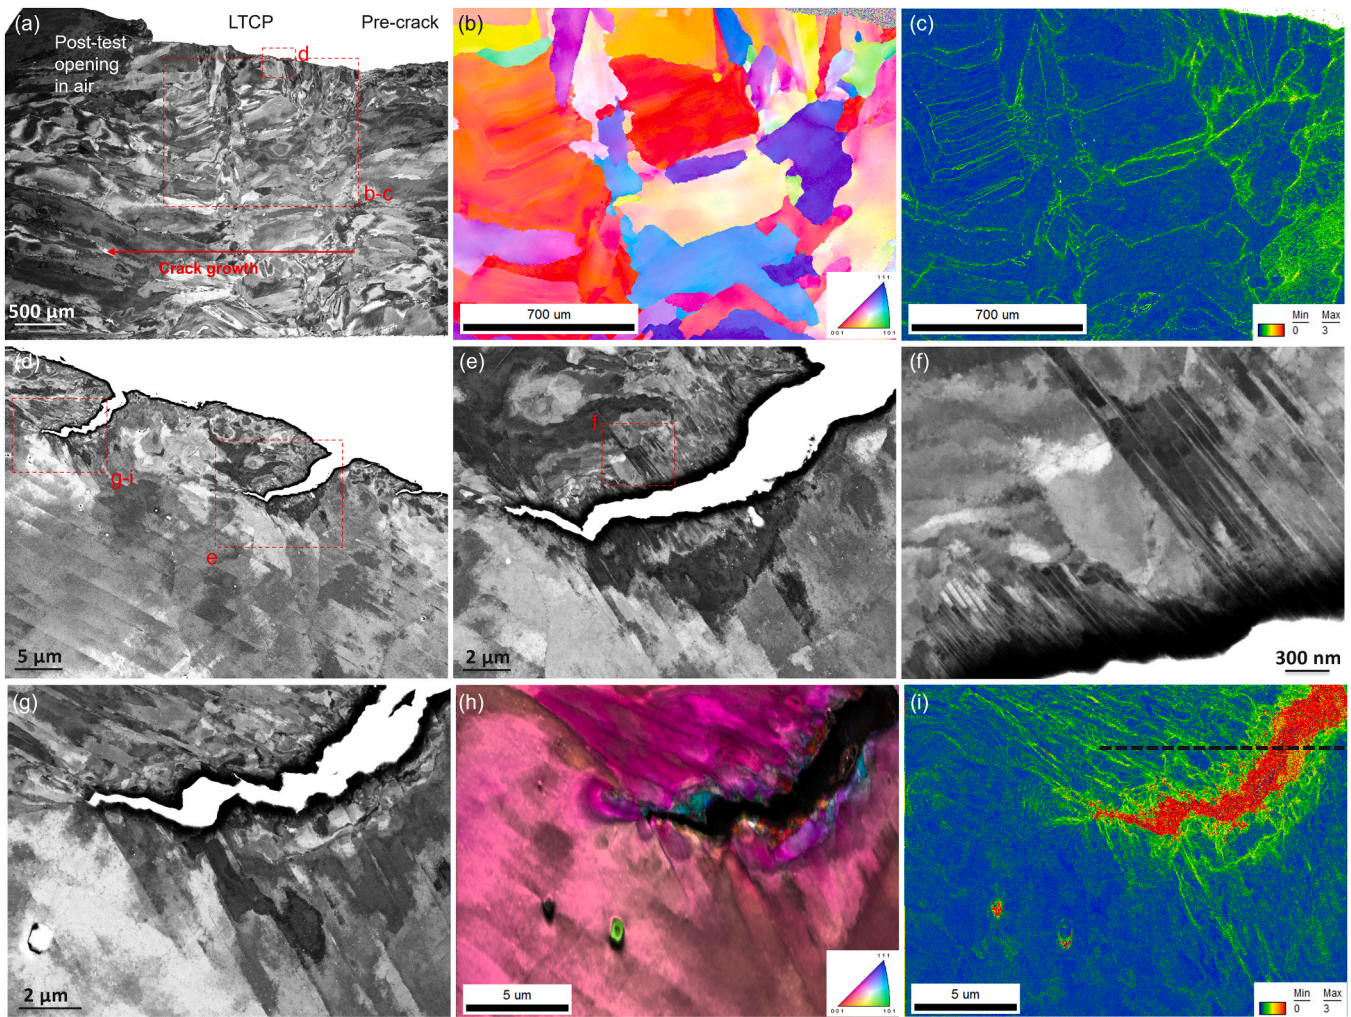
As shown in Fig. 9(d), extensive secondary cracks developed in the crack-extended region. A very thin oxide layer is observed in these regions (black contrast in Fig. 9(e-g)), particularly in comparison to the thicker oxide formed in the "pre-crack" region exposed to high-temperature water and the oxide-free "post-test opening in air" region. The observed variations are consistent with a decreasing ECP during the post-shutdown cold period, driven by oxygen consumption and hydrogen generation from oxidation reactions. Oxide thickness is primarily controlled by temperature and time, via kinetic effects, and inversely by ECP, through electrochemical mechanisms.

Localized deformation with extensive formation of shear bands in crack extended region were observed, particularly ahead of the crack tips (Fig. 9(h-i)). In general, the plastic deformation is not localized beneath the main cracked surface, as shown by the cross-sectional EBSD either aligned with (in Fig. 9(b-c)) or perpendicular to (in Fig. 10(b-c)) the crack growth direction. Fig. 10(e-f) demonstrate that plasticity is only localized ahead of the crack tips, where extensive shear bands and nano-twins were formed.

Fig. 9. Cross-sectional SEM and EBSD images of specimen #2. The cross section was prepared aligned with the crack growth direction. (a, d-g) images by back-scattered electron detector; (b, h) IPF figures; (c, i) KAM figures. The dotted line in (i) indicated the location of lamella liftout for TEM.

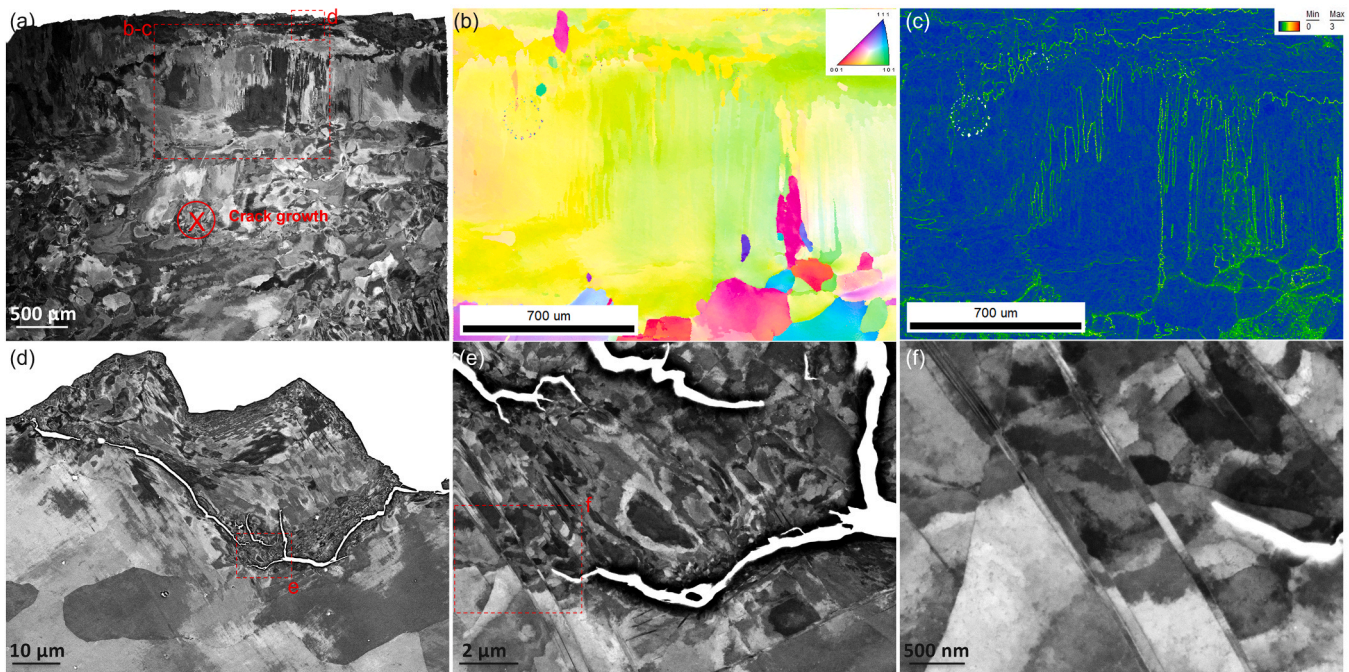
Fig. 9 to Fig. 10. The cross-sections were prepared either parallel or perpendicular to the crack growth direction, as shown in Fig. 9 and Fig. 10, respectively.

Fig. 10. Cross-sectional SEM and EBSD images of specimen #2. The cross-sectional was prepared perpendicular to the crack growth direction. (a, d-f) images by backscattered electron detector; (b) IPF figure; (c) KAM figure.

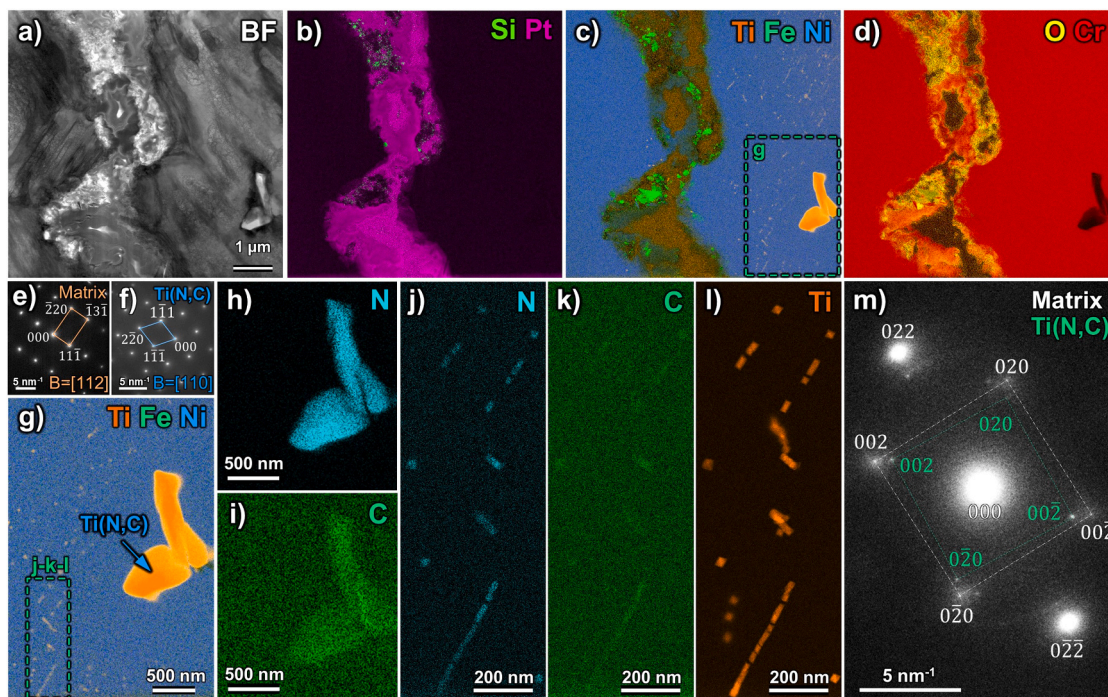
A TEM lamella to observe a secondary crack was prepared from specimen #2. The location of the FIB liftout was crossing the crack path, indicated with a dotted line in Fig. 9(i). The STEM on the lamella is showed in Fig. 11. The crack can be clearly observed by the EDS(Pt) map, which shows the Pt deposited on it. There are also some nanometric round SiO particles at the crack, which could be contamination coming from the previous surface polishing process for the EBSD. The EDS maps allow to identify multiple sub-micrometer Fe-oxide particles inside the crack (Fig. 11(c-d)).

A micrometer-size Ti(N,C) is observed in Fig. 11(g-i). The selected area diffraction pattern (SADP) from Fig. 11(f), confirms the face centered cubic (FCC) crystal structure of the Ti-carbonitride with a lattice parameter of a ≈ 4.28 Å. Additionally, the STEM-EDS mapping

(Fig. 11(c) and (g)) show a region on the right side of the crack with many dispersed nanometer-size Ti-rich particles. Fig. 11(j-l) show a higher resolution of the EDS maps containing the small particles. The analyses indicate that the nanometer-size particles are also Ti(N,C). The average chemical composition of the two sizes of Ti(N,C) are presented in Table 4. A higher N content and approximately half the C atomic content are observed in the smaller Ti-carbonitrides compared to the micrometer-sized Ti(N,C). The majority of the nanometer-sized Ti(N,C) are cuboidal, measuring about 25 nm, but some are rectangular, measuring 25 nm in one direction and under 100 nm in the other. The Fig. 11(m) shows a SADP from a nanometer-size particle with the matrix oriented near the [100] axis. It is possible to observe a similar orientation of the carbonitride and the matrix (near cube-on-cube orientation relationship) with a higher lattice parameter of the nanometer-size particle respect to the matrix ($a \approx 4.25$ Å and $a_{\text{Matrix}} \approx 3.60$ Å, respectively). The region with nanometer-sized Ti(N,C), probably corresponds to the dendritic weld structure of Alloy 52.

Fig. 11. STEM in a lamella extracted at the crack tip (showed in Fig. 9(g)) from specimen #2. (a) BF STEM and (b-d) STEM-EDS showing the crack. The Pt is deposited on the crack gap during the lamella preparation by FIB. The Si could be coming from the surface polishing process. (e-f) TEM SADPs from the micrometer-sized Ti(N,C) and FCC-matrix, respectively. (g) EDS with both types of Ti(N,C) on the right side of the crack. (h-i) EDS of micrometer-sized Ti(N,C). (j-l) EDS of nanometer-sized Ti(N,C). (m) SADP from a nanometer-sized Ti(N,C) with the matrix oriented near the [100] axis.

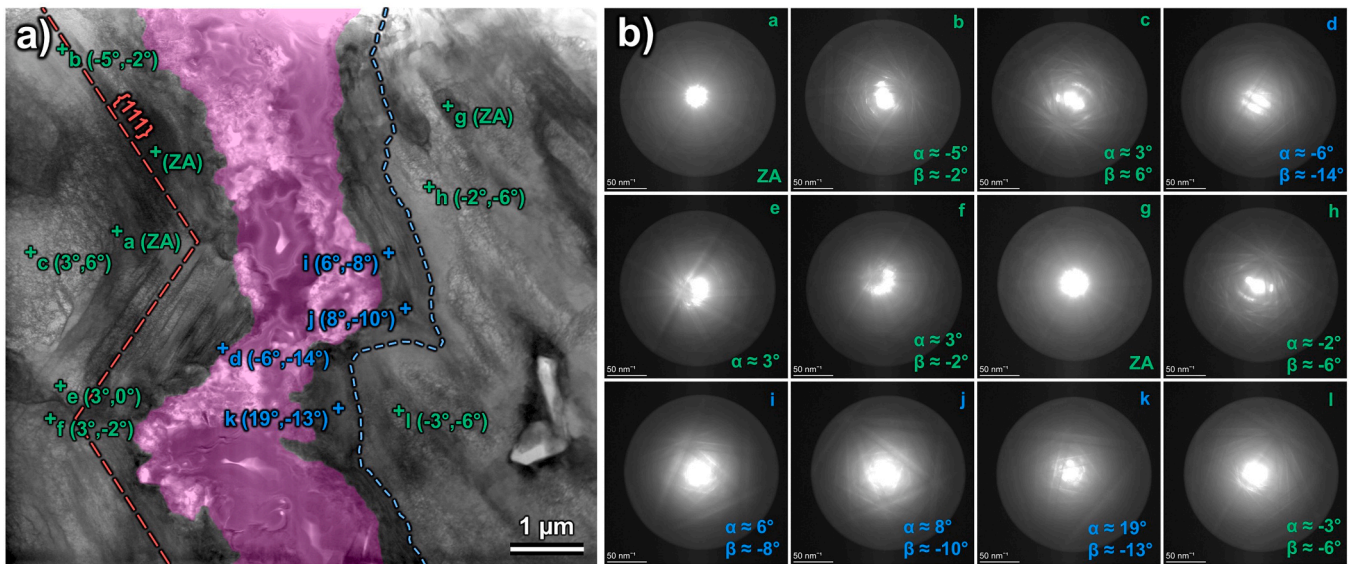
Fig. 12(a) shows a STEM micrograph of the lamella from specimen #2, with the secondary crack highlighted in color for clarity. Around the crack, the grain in the lamella was oriented along the zone axis (ZA) $B = [112]$. The FCC matrix exhibits parallel nanometric shear bands in specific directions, with zigzag crystal slip traces corresponding to the close-packed {111} planes. These nanometric shear bands are observed only on the left side of the crack, as shown in more detail in Fig. 13.

Multiple locations of the lamella from Fig. 12(a) were analyzed using CBED to acquire Kikuchi patterns (Fig. 12(b)), from which the tilt angles (α and β angles from the double tilt holder) were determined to reach the ZA. This allowed identification of grain regions that were heavily distorted or rotated due to the crack. Grains with tilt angles above 6° were

considered heavily distorted and were mainly located on the right side of the crack, at a distance of 500 ± 250 nm (see dotted blue line in Fig. 12 (a)). Notably, this heavily distorted region contains no carbonitrides.

Fig. 12. BF STEM of a crack from specimen #2. (a) The crack was colored for easy identification. Slip planes of {111} forming a zigzag pattern are visible parallel to the crack. The grain in the lamella was oriented around the zone axis (ZA) $B = [112]$. The tilt angles corresponding to a TEM double tilt holder (α and β) to reach the ZA at multiple sites of the lamella are indicated. (b) CBED micrographs of Kikuchi patterns corresponding to the locations indicated in (a).

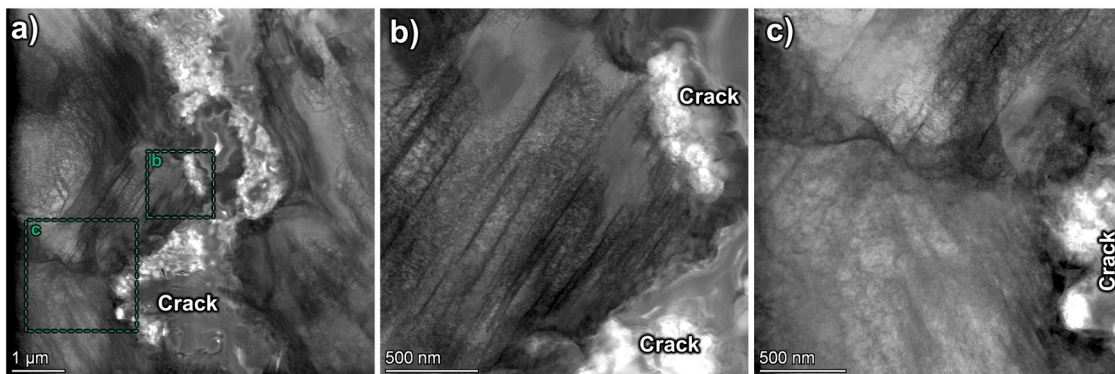
Fig. 13. BF STEM micrographs of a crack from specimen #2. (a) Full view of the crack. (b-c) Higher magnification details showing the parallel slip traces that follow the crack path on its left side (region without Ti-carbonitrides).
