Decommissioning of the Danish 5 MW research reactor DR2

Niels Strufe and Kurt Lauridsen
Danish Decommissioning

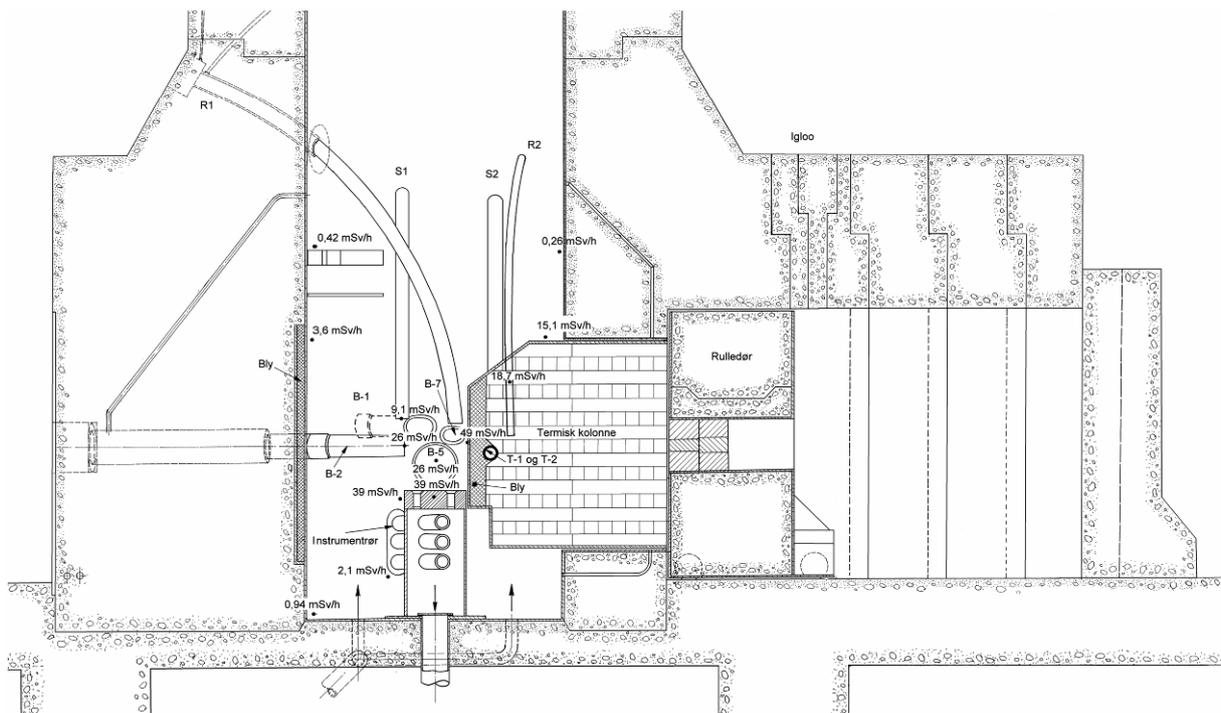
Figure 2 Cross-section of the reactor block and thermal column showing radiation levels measured with TL-dosimeters in the spring of 2001.

The cross-section shown in Figure 2 illustrates the remaining active components and shows the exposure rates in selected points. There were eight curved irradiation tubes ("S" and "R" tubes) that went down into the core region from the balcony, and eight horizontal beam tubes. The inner parts of these tubes still contained activity above clearance levels. But the major radiation sources and those requiring some attention during dismantling were the fuel element grid plate and thermo elements placed in the nose of the thermal column. The dose rate measurements were made as part of a characterisation project [3] carried out some years before start of the decommissioning.

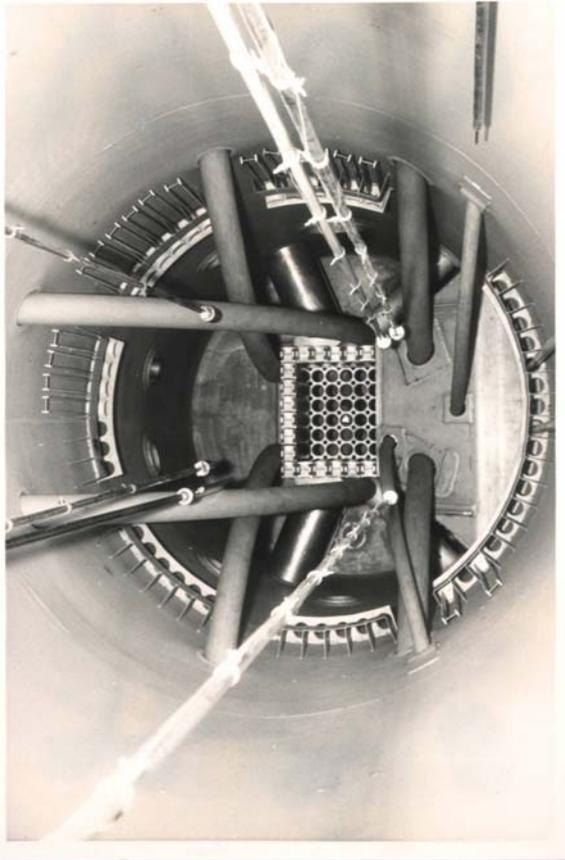
Figure 3 Remaining internals of the reactor tank

The photo in Figure 3 shows the internals seen from above just prior to the start of dismantling. The curved "S" and "R" irradiation tubes could be pulled out fairly easy by hand, as illustrated in Figure 4. Only the inner one metre or so had to be cut off and disposed of as radioactive waste. The horizontal beam tubes were somewhat more difficult

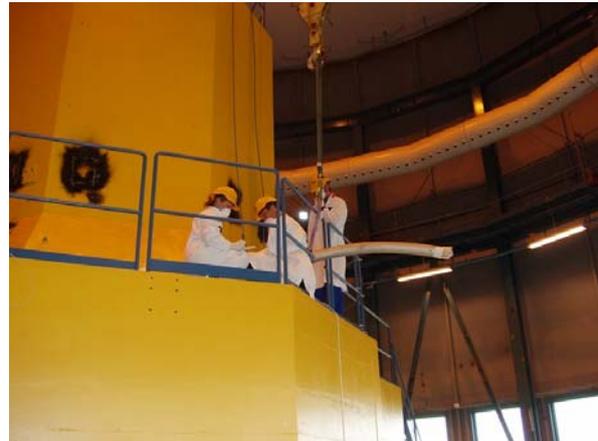
Figure 4 Removal of an "S" tube

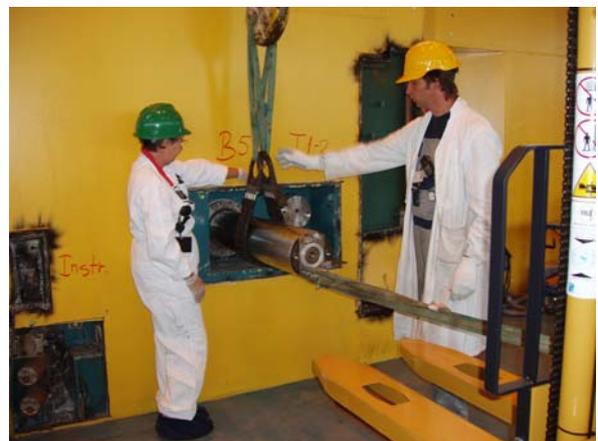
Figure 5 Removal of a beam tube (plug)

to remove. For one thing they were much heavier and had to be pulled out by means of a small truck. But one of them also was stuck so firmly that pulling it out was abandoned. Instead it was left for being cut out together with 10 cm of the surrounding concrete by diamond wire cutting in conjunction with the demolition of the biological shield.

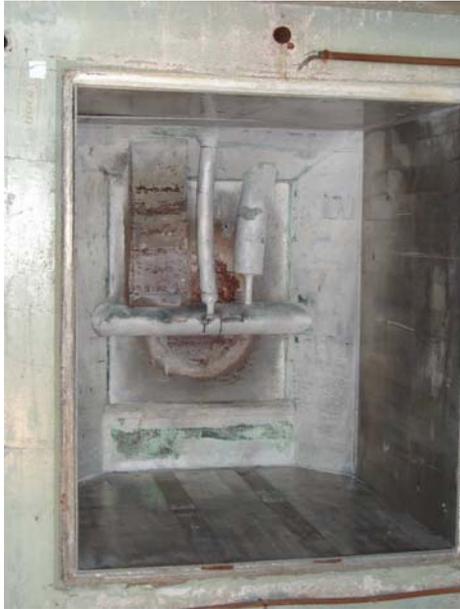
Figure 9 Thermal column with lead nose exposed

As mentioned earlier, the nose of the thermal column and the grid plate were found to be the most active components in the reactor tank. The radiation level measured on the outer side of the lead nose after removal of the graphite stringers (Figure 9) was around 2 mSv/h. From previous measurements it was known that the highest radiation level inside the reactor tank was right in front of the lead nose with a level of 60 mSv/h. The majority of the radiation was considered to be coming from the grid plate but a fair amount originated from the lead nose with its position directly up to the core of the reactor. After removal of the graphite it was found that the majority of the radiation in the thermal column could be located to the central part of the lead nose containing built-in thermo elements.

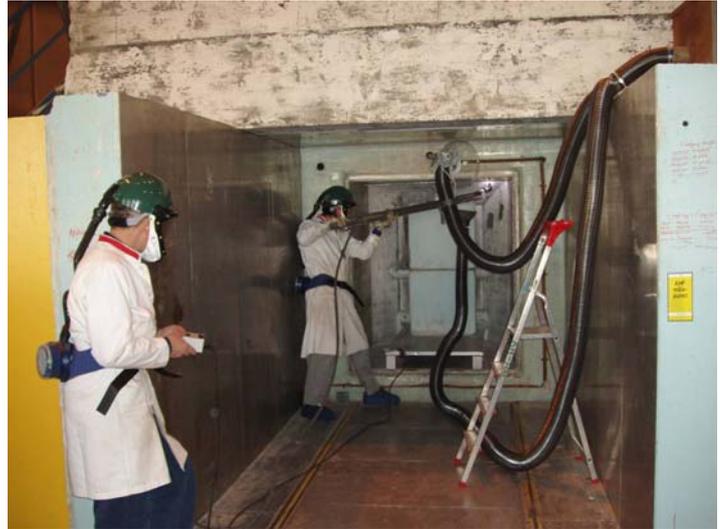
Figure 10 Plasma cutting of the lead nose

The lead nose was cut loose from the thermal column casing by means of plasma cutting. The plasma cutter was mounted on an extension arm of 2 metres in order for the operator to have some distance to the source. In addition, the nose was shielded by means of 300 mm thick concrete blocks, cf. Figure 10. The cutting was performed by 2 operators, with one doing the cutting with the extension arm and the second one managing the power switch from a distance of approximately 4 metres to the column. This was found to ensure sufficient safety in relation to the radiation but also to the fact that the plasma cutter requires high voltage supply and works by electrical contact between the cutter and the medium to be cut.

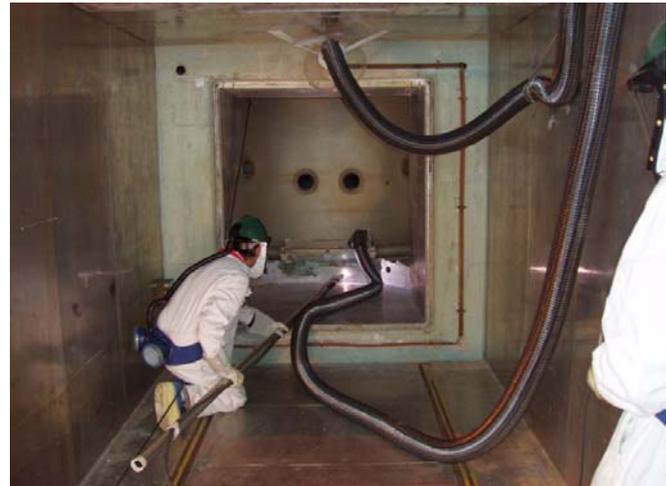
Figure 12 Grid plate being cut loose

The plasma cutter subsequently was used in the same manner to cut out the grid plate and other remaining structures in the reactor tank, cf. Figure 11 and Figure 12. Furthermore, plasma cutting proved very useful for cutting up the thermal column casing, which was made of 19 mm aluminium plates lined with 6 mm Boral plates on the side facing the graphite. A number of tests were made with various cutting tools, such as circular saws of different types and plasma cutter. The problem was to cut through a construction consisting of both the 'soft' material aluminium and the particularly 'hard' Boral plates, with a thickness totalling 25 mm. The plasma cutter did it quickly and without problems.

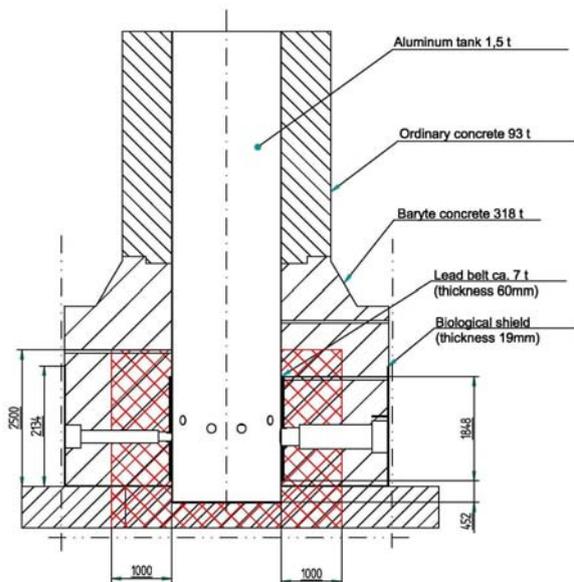
Based on the drill core examinations and analyses in DD's Clearance Laboratory, it was determined that the non-clearable concrete (the "active profile") extended cylindrically from the core in a thickness of one metre in the concrete structure, cf. Figure 13. Actually, it was a bit less, but to be on the safe side the profile was determined as stated. The height of the active cylinder was 2.5 metres from the floor with the same radius as mentioned above and 25 cm into the floor deck towards the basement. For practical reasons it was determined that the floor (deck thickness = 60 cm) underneath the reactor block was to be removed in its entirety.

Around the horizontal beam tubes and instrument thimbles a higher degree of activation of the concrete was found close to and around the tubes. It was, therefore, decided that a profile corresponding to the outer radius of the active tube + 10 cm was to be removed as radioactive waste.

Figure 13 Cross section of the biological shield. Only the crosshatched part was disposed of as radioactive waste

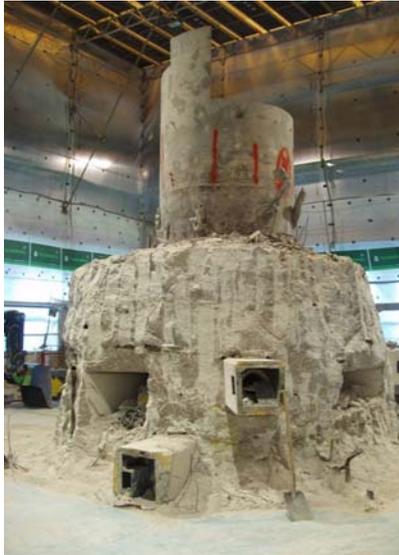
Figure 16 Radioactive parts exposed
