Detector contamination from a broken sealed test source

Radioactivity measurements laboratory in Bremen

A super-GAU¹ in the lab

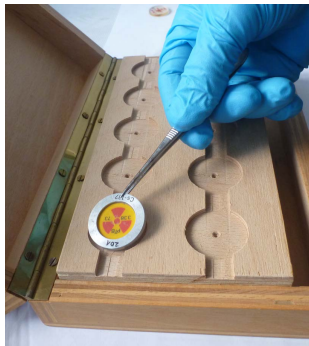
Das Präparat mit der Gravur PTB / 558-73

enthält ^{137}Cs in Form von CsCl

mit einer Aktivität von 11,4 Mikrocurie

Test source (radiation?) damage

- The contaminated HPGe detector endcap was cleaned in several steps by conventional means.
- Still, $2.36 \cdot 10^{-3}$ cps remained in the ^{137}Cs area, 9.2 times the value before the contamination.
- Consequences: MDAs increase. Acceptable for routine environmental samples.
- Good news: the detector was undamaged by the decontamination efforts.
- More sophisticated decontamination approach?
- Autoradiography for localizing the contamination? Chemical agents for binding the remaining ^{137}Cs and removing it?
- Future prevention: regular leak tests?

Sealed test sources DO age and can get leaky!

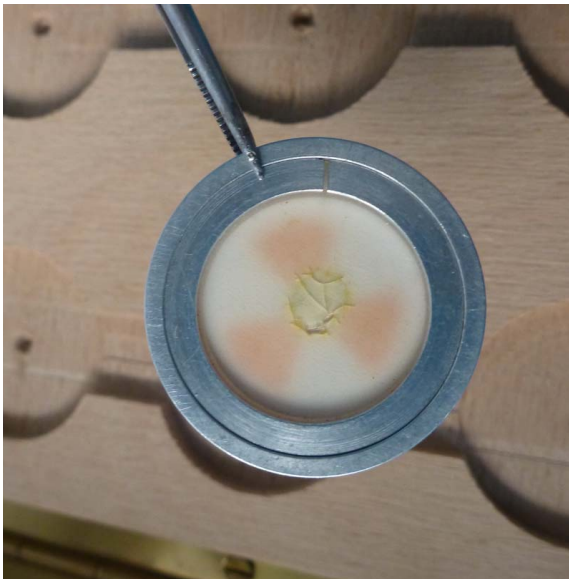
Estimated 4% (7.5 kBq)
of the total activity of
(originally) sealed
 ^{137}Cs test source
contaminated the
detector endcap.

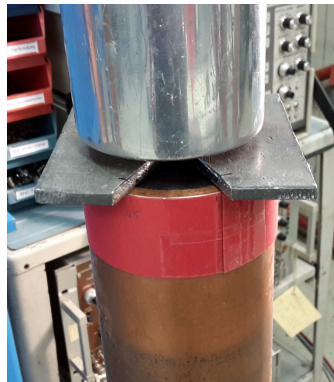
Where exactly is the contamination located?

- Localization of contamination on the detector and inside the shielding
- Only detector endcap was contaminated

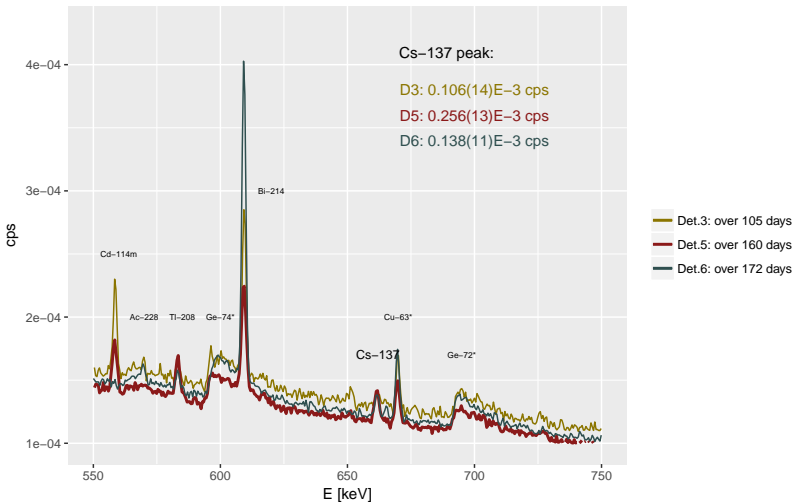
Long-term background spectrum

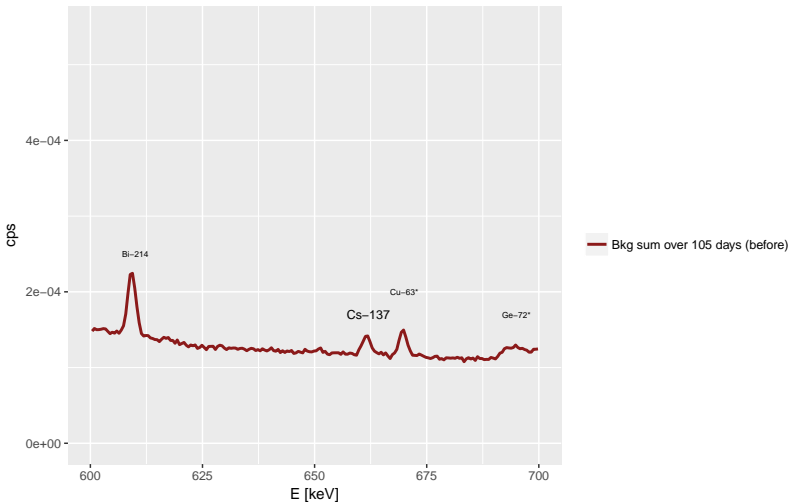
Remaining contamination of detector 5
