NKS-197
ISBN 978-87-7893-264-8

Wire System Ageing Assessment and Condition Monitoring (WASCO)

Paolo F. Fantoni
Institute for Energy Technology (IFE), Norway

July 2009

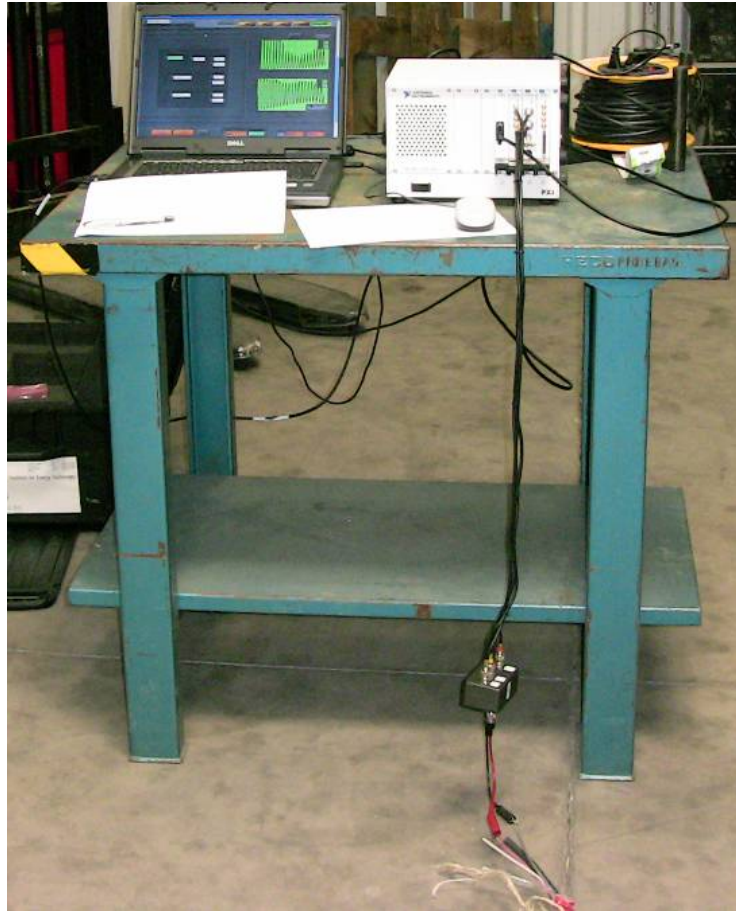
Figure 1 Testing facility for LIRA, at Tecnatom Lab

Figure 1 shows the experiment arrangement during the LIRA tests on the cable samples.

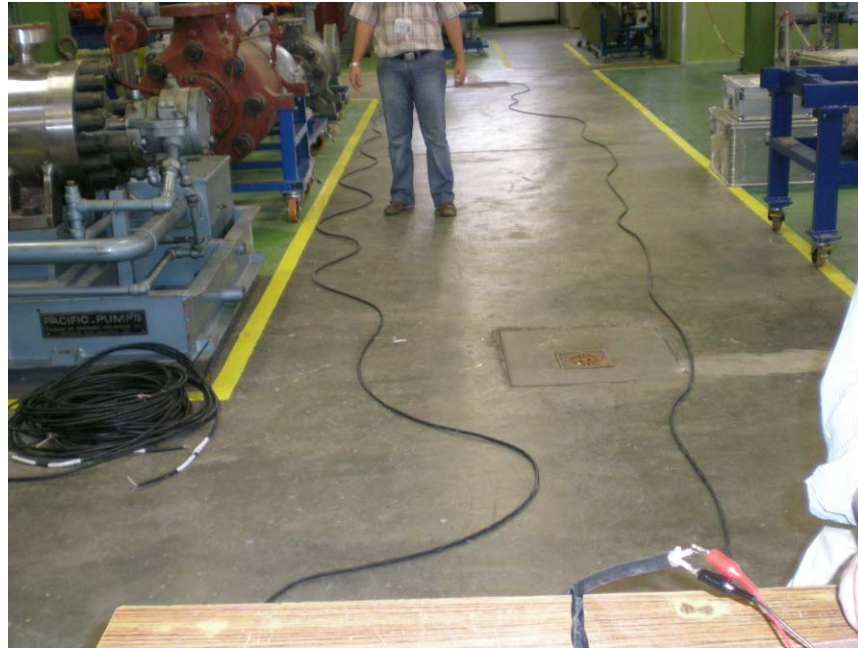
Figure 5: Cable disposition

In this case, equipment is a bit bigger than the indenter and the cable must be in a condition similar to the way it would be in the plant, this is, cable cannot be coiled so it is necessary to have much space for the cable, as can be seen in figure 5. According to the kind of oscilloscope used, the output can be saved in a memory card or downloaded to a computer at the same time they are being generated.

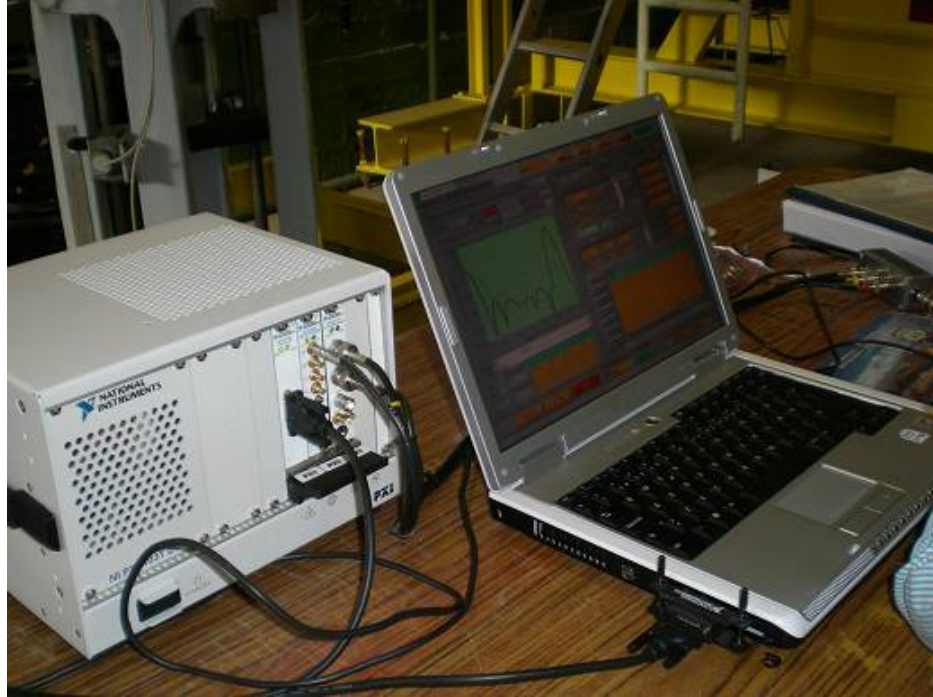
Figure 6: LIRA Generator, LIRA modulator and computer used in the tests

The whole equipment for LIRA consists of several modules. These modules are: the LIRA Generator (Arbitrary Waveform Generator), the LIRA modulator and a computer with an special software (see figure 6).

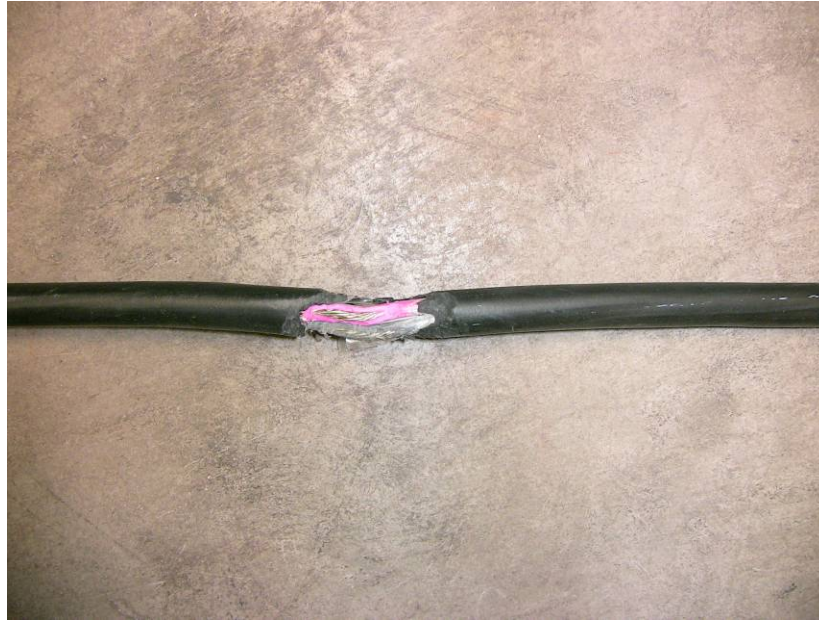
Figure 8 TXM2 gouge of 2 wires (dry)

Two types of mechanical damage were tested: TXM1 had a cut down to the insulation of 2 conductors, see Figure 9, while TXM2 had a gouge as shown in Figure 8.

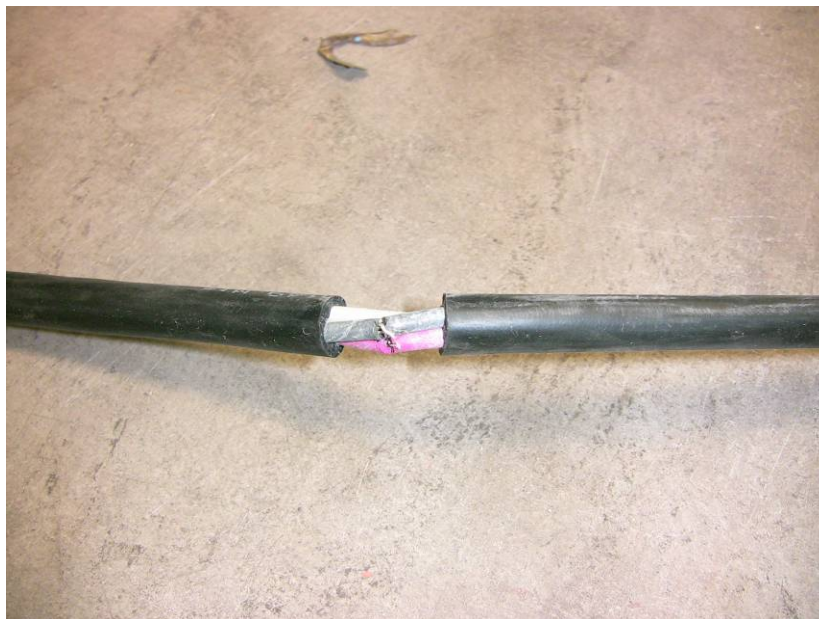
Figure 9 TXM1 cut on the insulation of 2 wires (dry)

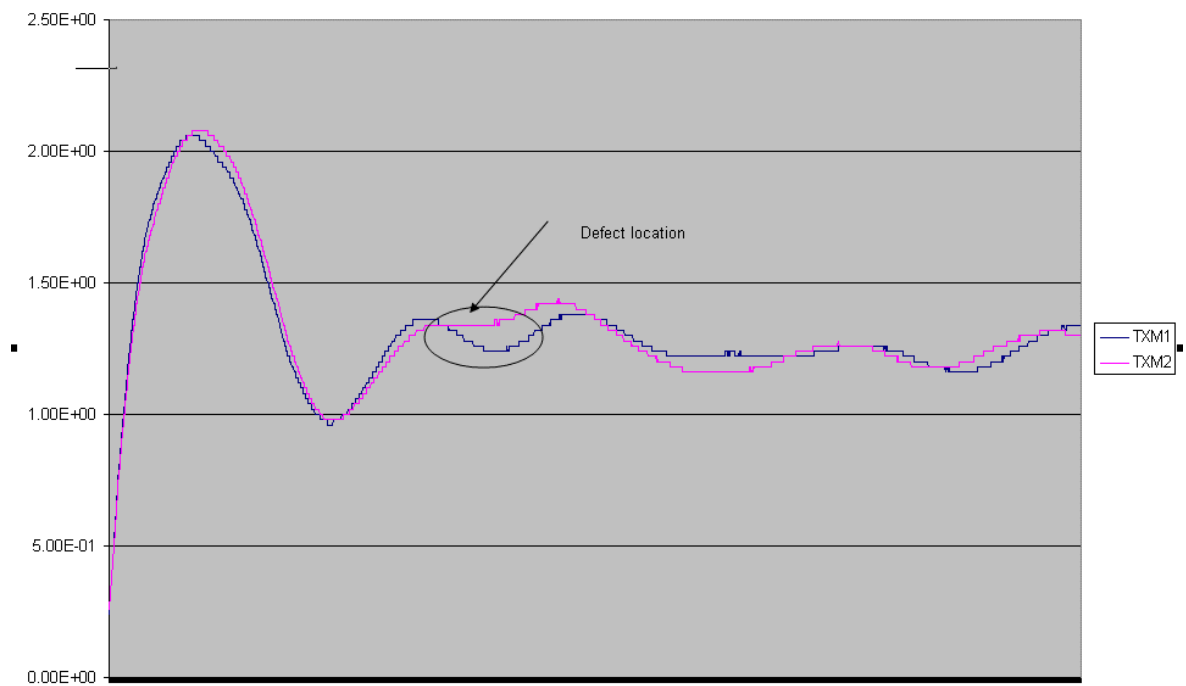
Figure 10 TDR trace for TXM1 and TXM2

Figure 10 shows the traces for TXM1 and TXM2. Although some possible features are visible in the damaged areas, no clear diagnosis can be

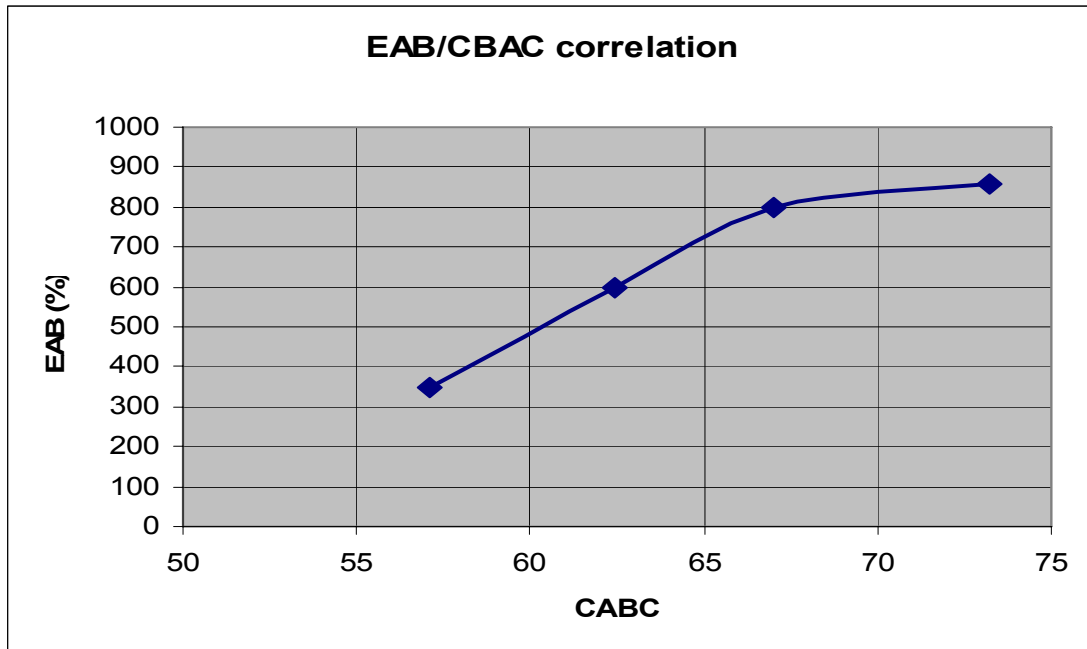
Figure 18 CBAC/EAB correlation for EPR/EPDM

Figure 18 contains the correlation between the EAB indicator and CBAC on the 4 measured samples. It is interesting to see that this correlation is practically linear between 20 and 60 years, which makes easier interpolation and, more important, extrapolation to the end of life.
