BREDA – a path to support LTO for the current units

Pål Efsing

The idea: Barsebäck as a Research and Development Arena

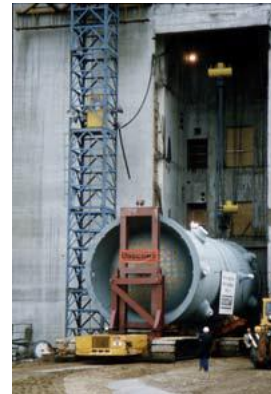
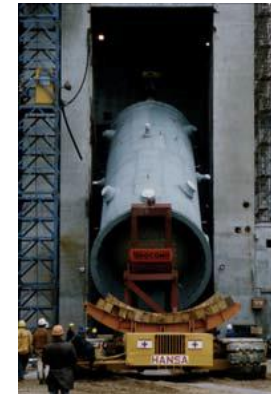
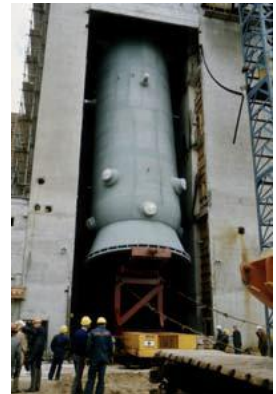
Reactor pressure vessel installed in B2, photo: Barsebäck Kraft

Extraction of the trepans:

Samples were extracted by drilling

Work performed by Ringhals AB under the auspices of Energiforsk

The technique has since been utilized to extract materials from the pressurizer of Ringhals 2

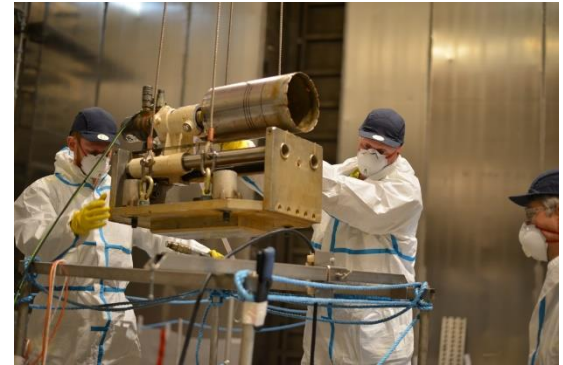
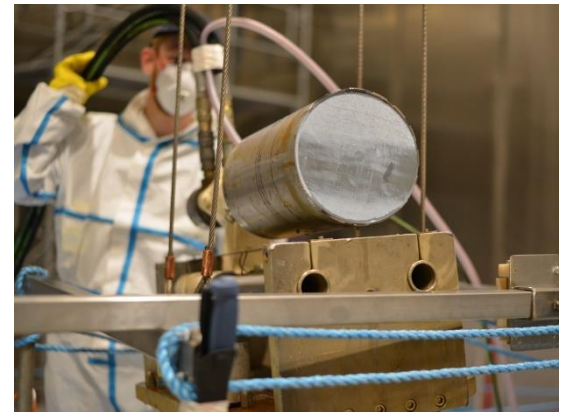
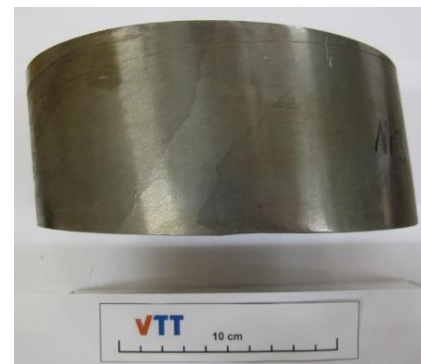
Test scope:

RPVH studied from two trepans

- Investigations *finished*

Beltline weld seams in two directions

- Axial weld seam W14 (*finished*)
- Circumferential weld seam W16 (**underway**)

Trepans investigated at $\frac{1}{4}$ T depth

- Corresponding with surveillance program

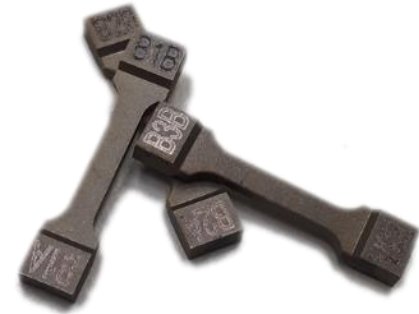
Mechanical testing:

Test program includes:

- Hardness testing
- Tensile testing
- Impact testing ("Charpy-testing")
- Fracture mechanics testing

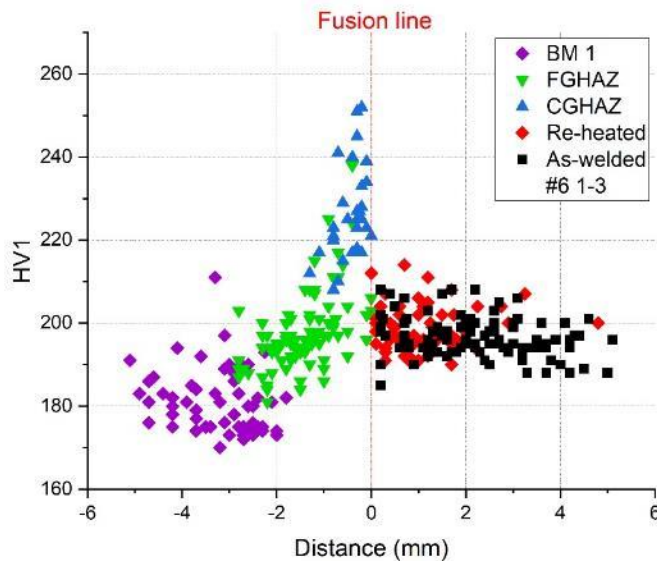
Hardness profile over fusion boundary - Beltline

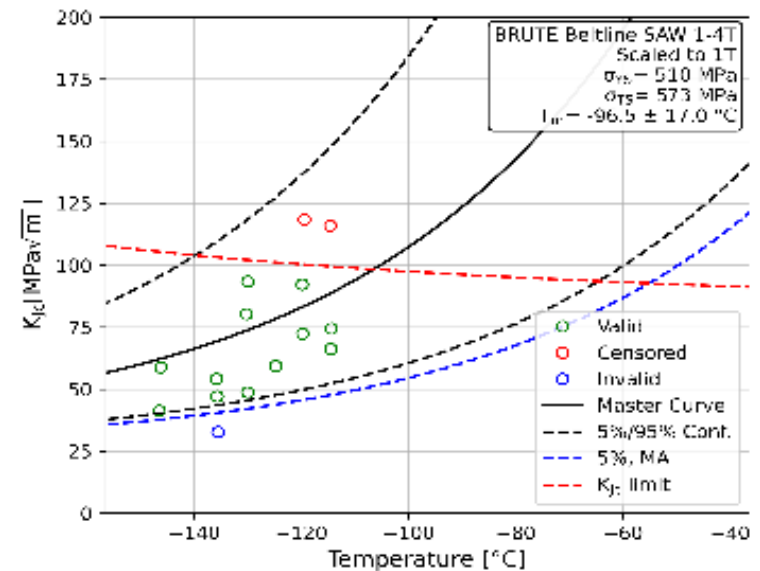
Fracture mechanics testing
"Master curve" - Beltline

The use of miniature CT-specimens gives useable results with respect to the needs for fitness to service and regulatory acceptance needs
