Barsebäck as a Research and Development
Platform, Extraction and Analysis of
Service-aged and Irradiated Reactor
Pressure Vessel Material;
Summary of 2019 activities

**Final Report from the NKS-R BREDA-RPV 2019 activity
(Contract: AFT/NKS-R(19)118/1)**

The main objective of the BRUTE (Barsebäck RPV material used for true evaluation of embrittlement) project is to determine the mechanical and microstructural properties of Barsebäck 2 (B2) reactor pressure vessel (RPV) welds from the head and core regions in accordance with the objectives set out in the BREDA (Barsebäck Research & Development Arena) project. Simultaneously the project offers an opportunity to pioneer the new infrastructure in the Centre for Nuclear Safety, CNS.

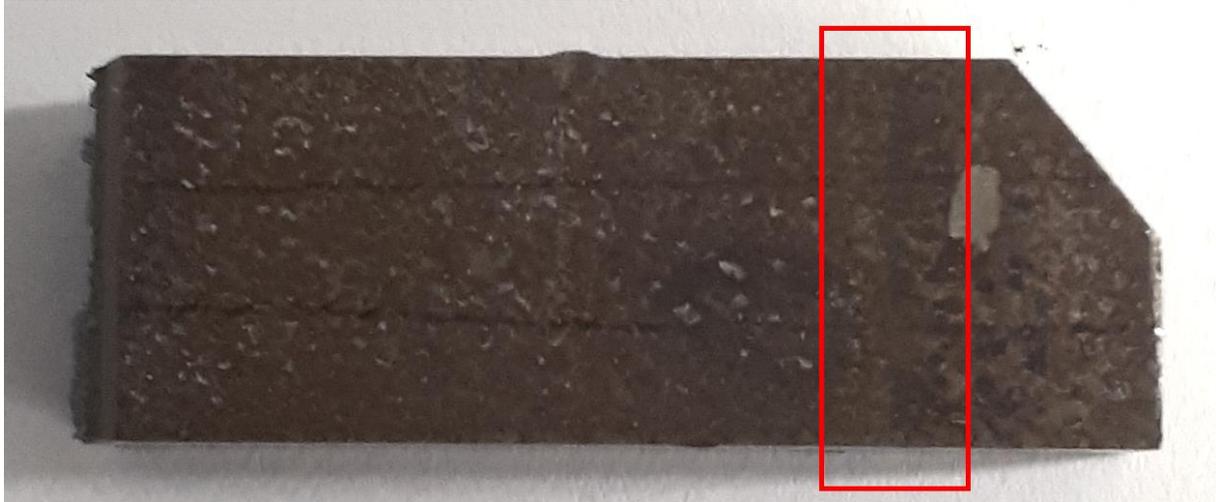
Figure 7. The chamfered edge in the end of the tested specimen half of B3B-11. Fracture surface is on the left side. The face of the specimen is towards the camera and the impact line with the anvil is inside the red rectangle.

Due to the limited amount of weld material in $\frac{1}{4}T$ depth, specimen B2B-11 had one chamfered edge. This is illustrated in Figure 7. The chamfer was measured, and it was deemed to be outside the span of the anvil. This was confirmed during post-test inspection and is visible in Figure 7. Specimen B2B-11 was also tested in the lowest test temperature to minimise ductility and thus ensure the harmlessness of the chamfer.
